DLNR Briefing for State House of Representatives

Kona Low Storms March 2026

Department of Land and Natural Resources

April 20, 2026

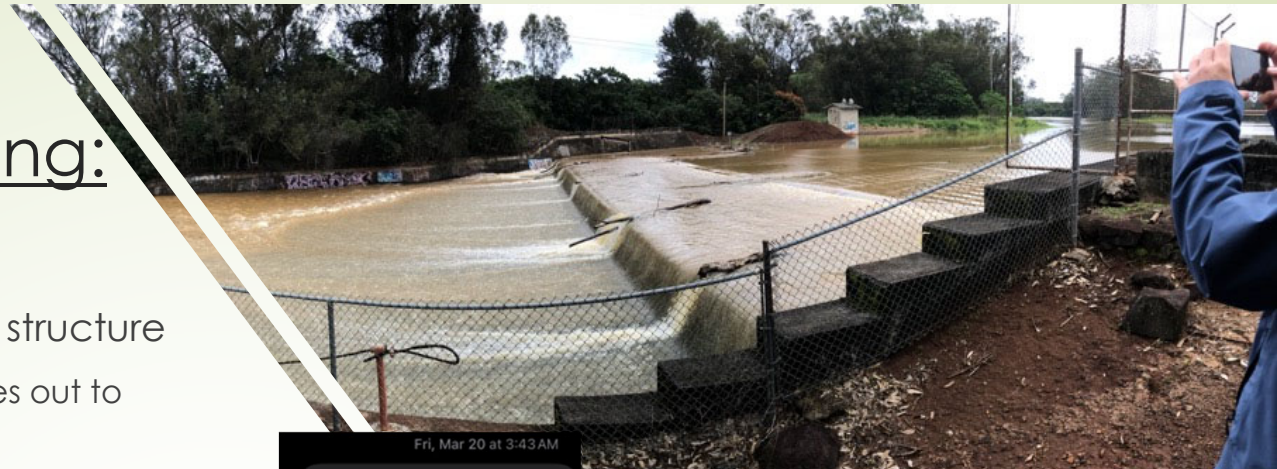
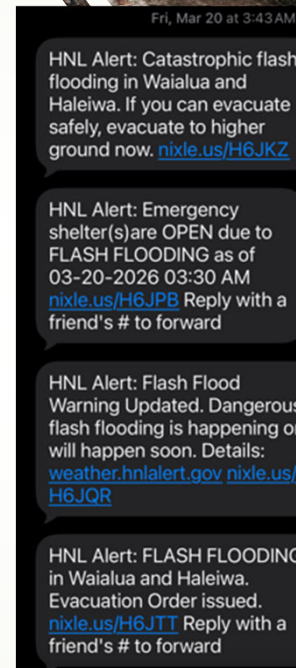
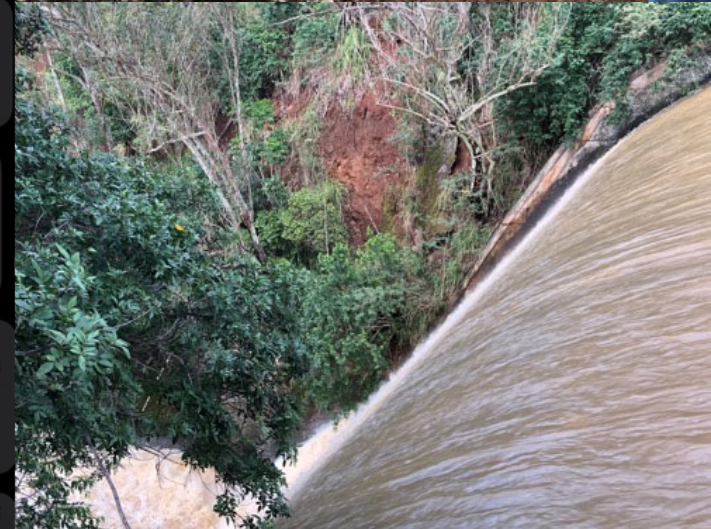
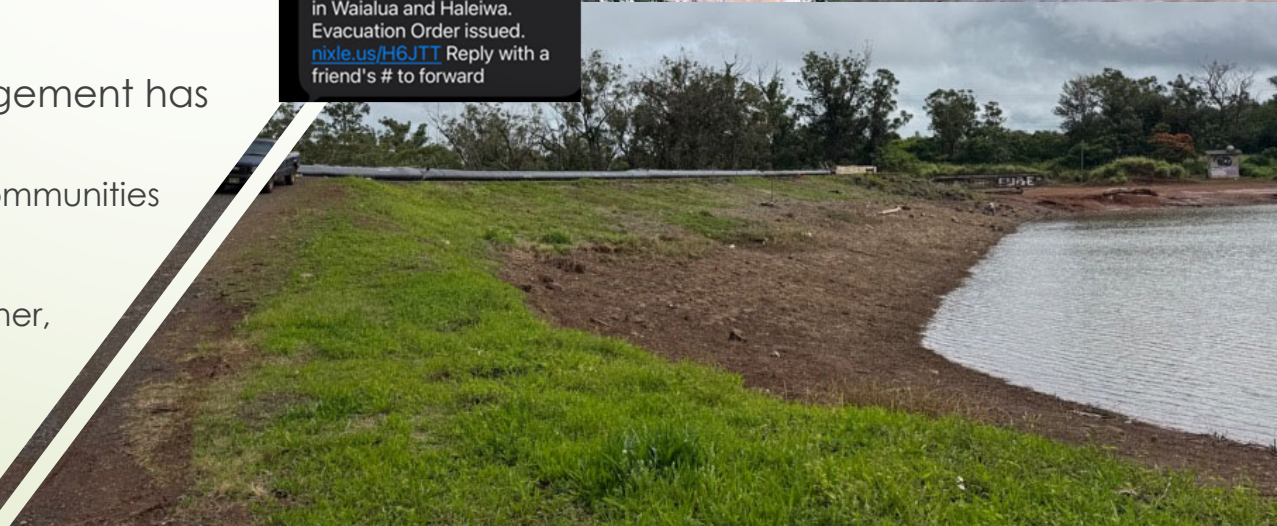
2 – Potential Dam Overtopping: Helemano 6 Reservoir

- At midnight on March 19, Helemano 6 Res. came within a 1-2 feet of overtopping the dam
 - Rose 15-ft in 2.5 hours
 - County ordered evacuation for a portion of Haleiwa
- Helemano 6 has serious deficiencies:
 - Undersized and deteriorated spillway
 - Embankment stability concerns
 - Defective outlet works
 - DLNR has restricted the water level
- Owner started plans to remove the dam, however this facility is anticipated to be transferred to State ADC. ADC has indicated a desire to remediate this facility

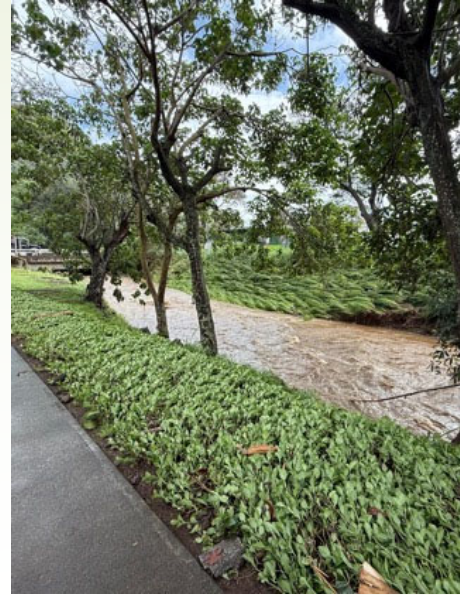
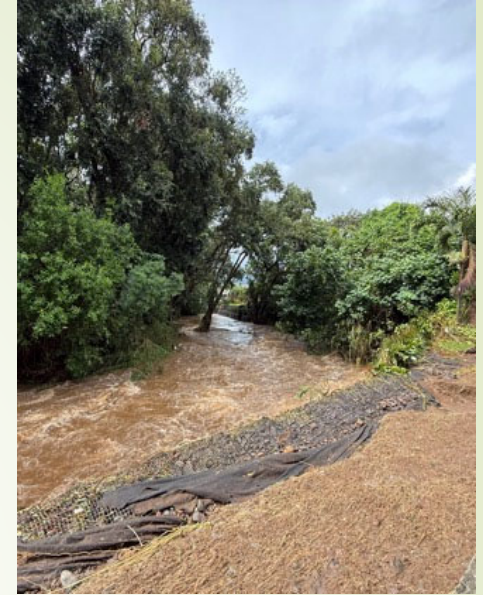
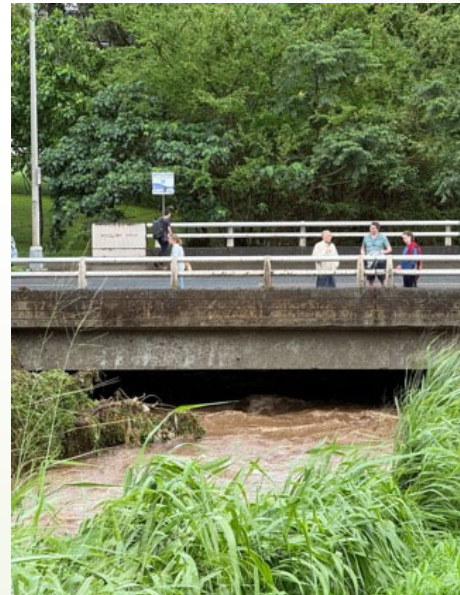
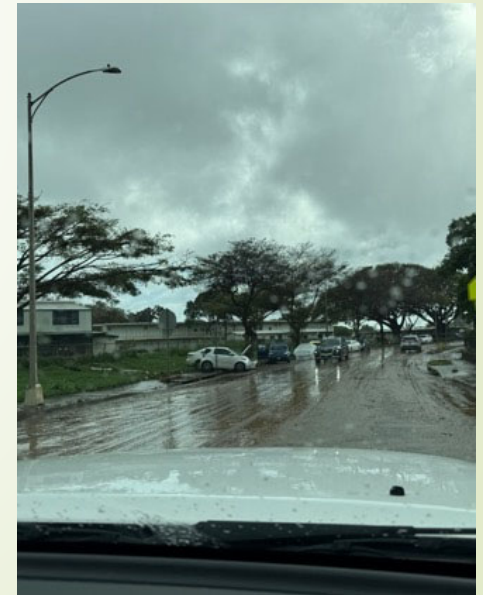
Manoa Stream at Woodlawn Bridge Findings

- ▶ Stream channel does not have capacity to handle 100 year storm event
- ▶ Woodlawn Bridge does not have capacity to handle 100 year storm and is prone to clogging.
- ▶ Large debris are transported down the channel
- ▶ DLNR will assess impact of removing trees on their portion of the stream
- ▶ Recommend Study to improve Bridge capacity and possibly debris catchment basin

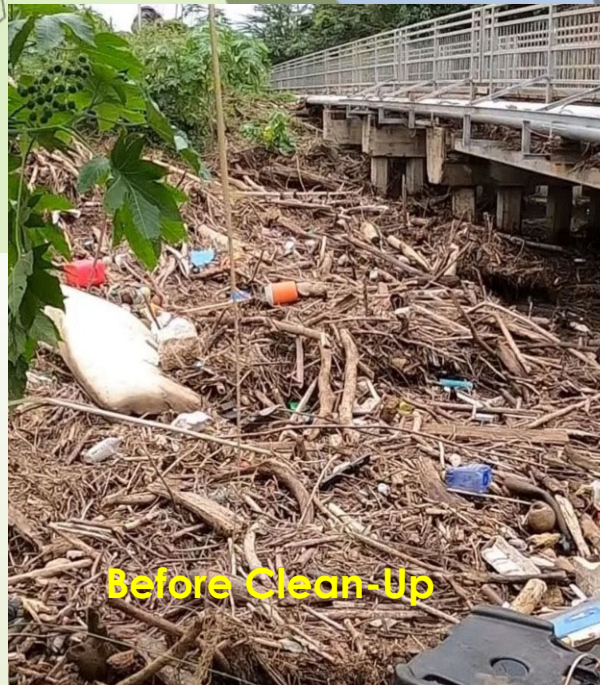
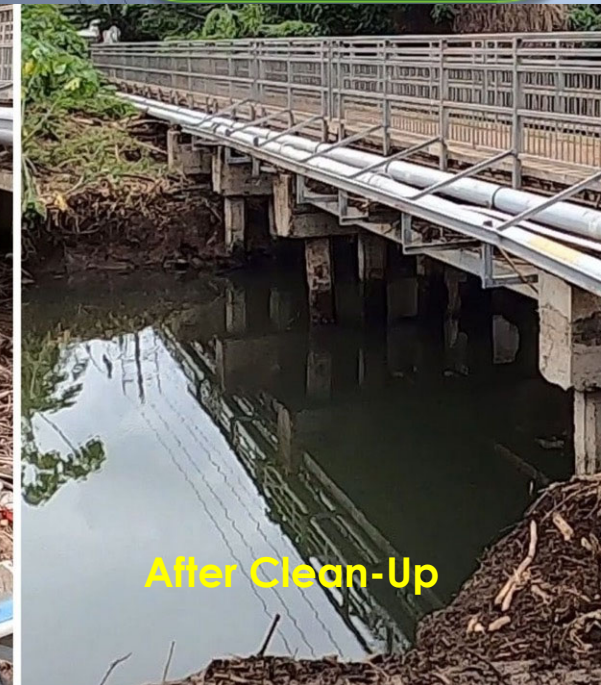
4 – Flood Risk: Waiawa Stream

- Stream does not have capacity to handle 100 year storm event
- Excessive amount of debris are transported down the stream from upstream private property
- DLNR inspects bridge periodically and had contractor retained to remove debris from bridge, Contractor did not show up. Retained second contractor to clean.

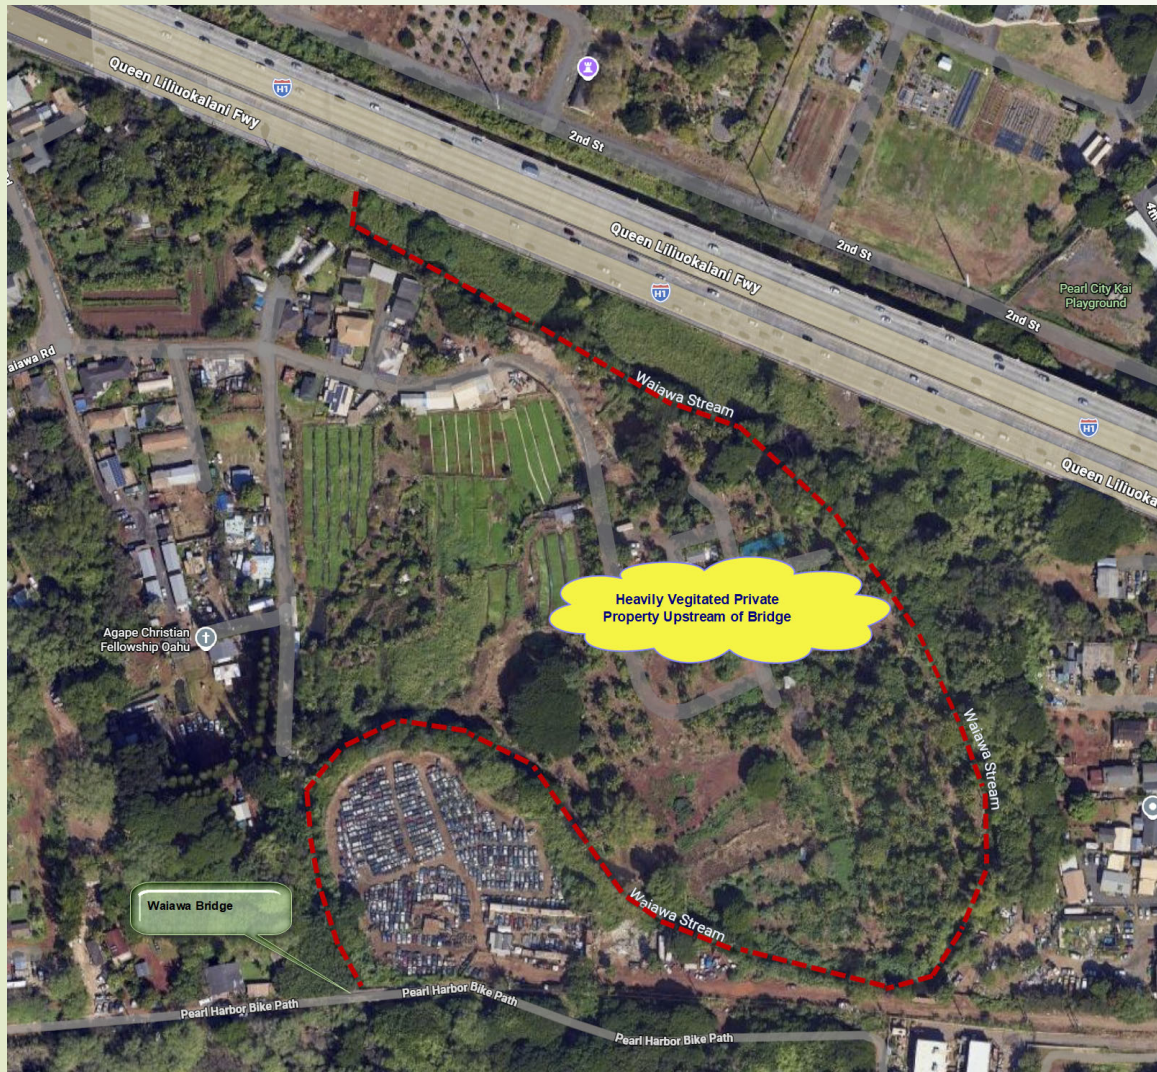
4 – Flood Risk: Waiawa Stream

- Stream does not have capacity to handle 100 year storm event
- Excessive amount of debris are transported down the stream from upstream private property
- Poor access around bridge complicate maintenance work

- DLNR will contract Quarterly cleaning.
- DLNR will conduct survey to identify possible location of debris and work with neighbors
- CIP to undertake sitework to allow access for heavy machinery needed to remove debris at bridge
- Study for possible mitigation actions
